Live Load Deflection Performance of Glued Laminated Timber Girder Bridges

Travis Hosteng, Brent Phares, Terry Wipf, Mike Ritter, and Doug Wood

Transportation Research Record: Journal of the Transportation Research Board, No. 1928, Transportation Research Board of the National Academies, Washington, D.C., 2005, pp. 174–182.

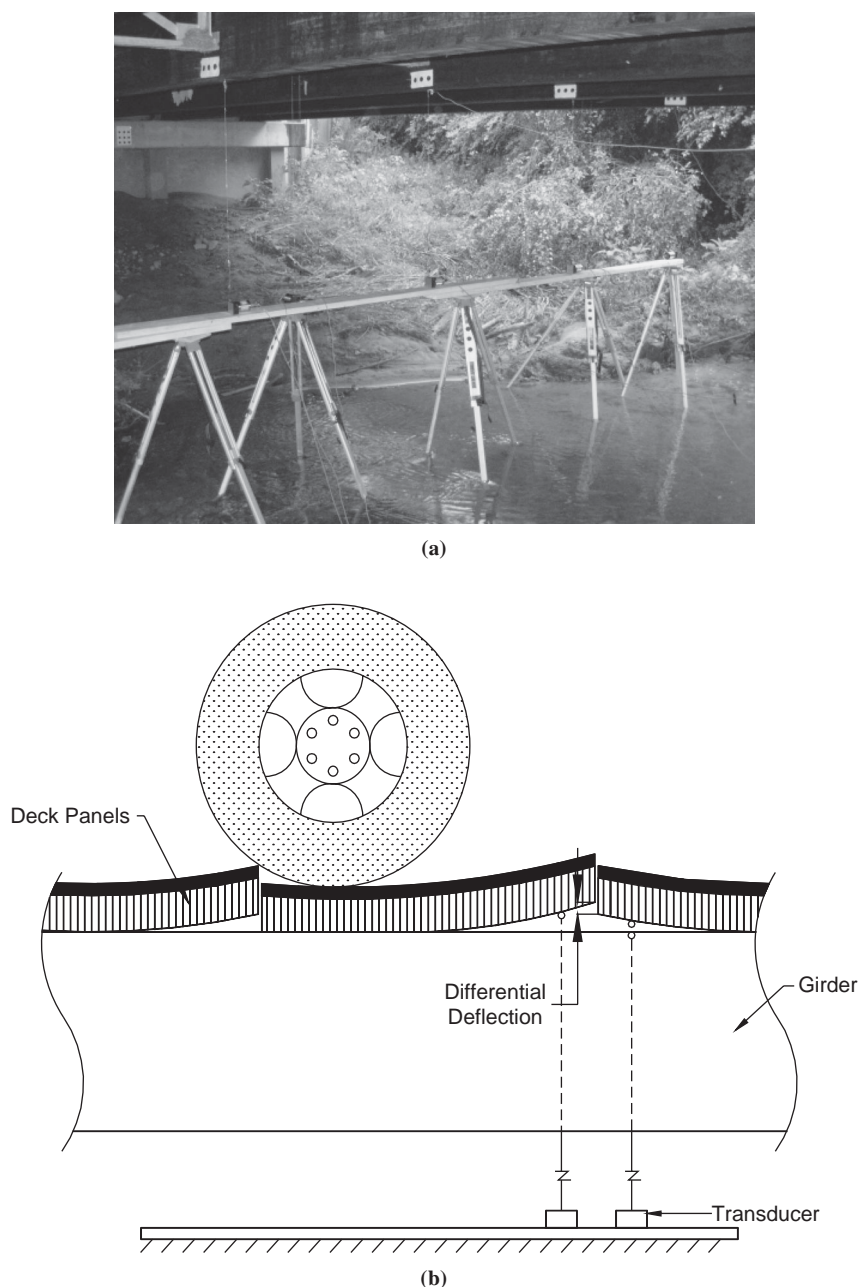
FIGURE 1 (a) Typical instrumentation setup for deflection measurement and (b) instrumentation setup for determination of differential panel deflection.

Field tests involved installing deflection transducers at midspan and quarterspan on both the bottom of the girders and the underside of the deck panels. Transducers were installed on the deck panels such that differential panel deflections could be calculated. A typical instrumentation setup is shown in Figure 1. All global deflections and panel
